DEVELOPMENT OF WELDING TECHNIQUES AND FILLER
METALS FOR HIGH STRENGTH ALUMINUM ALLOYS

Annual Summary Report
Project No. 07-1063

SOUTHWEST RESEARCH INSTITUTE
SAN ANTONIO HOUSTON

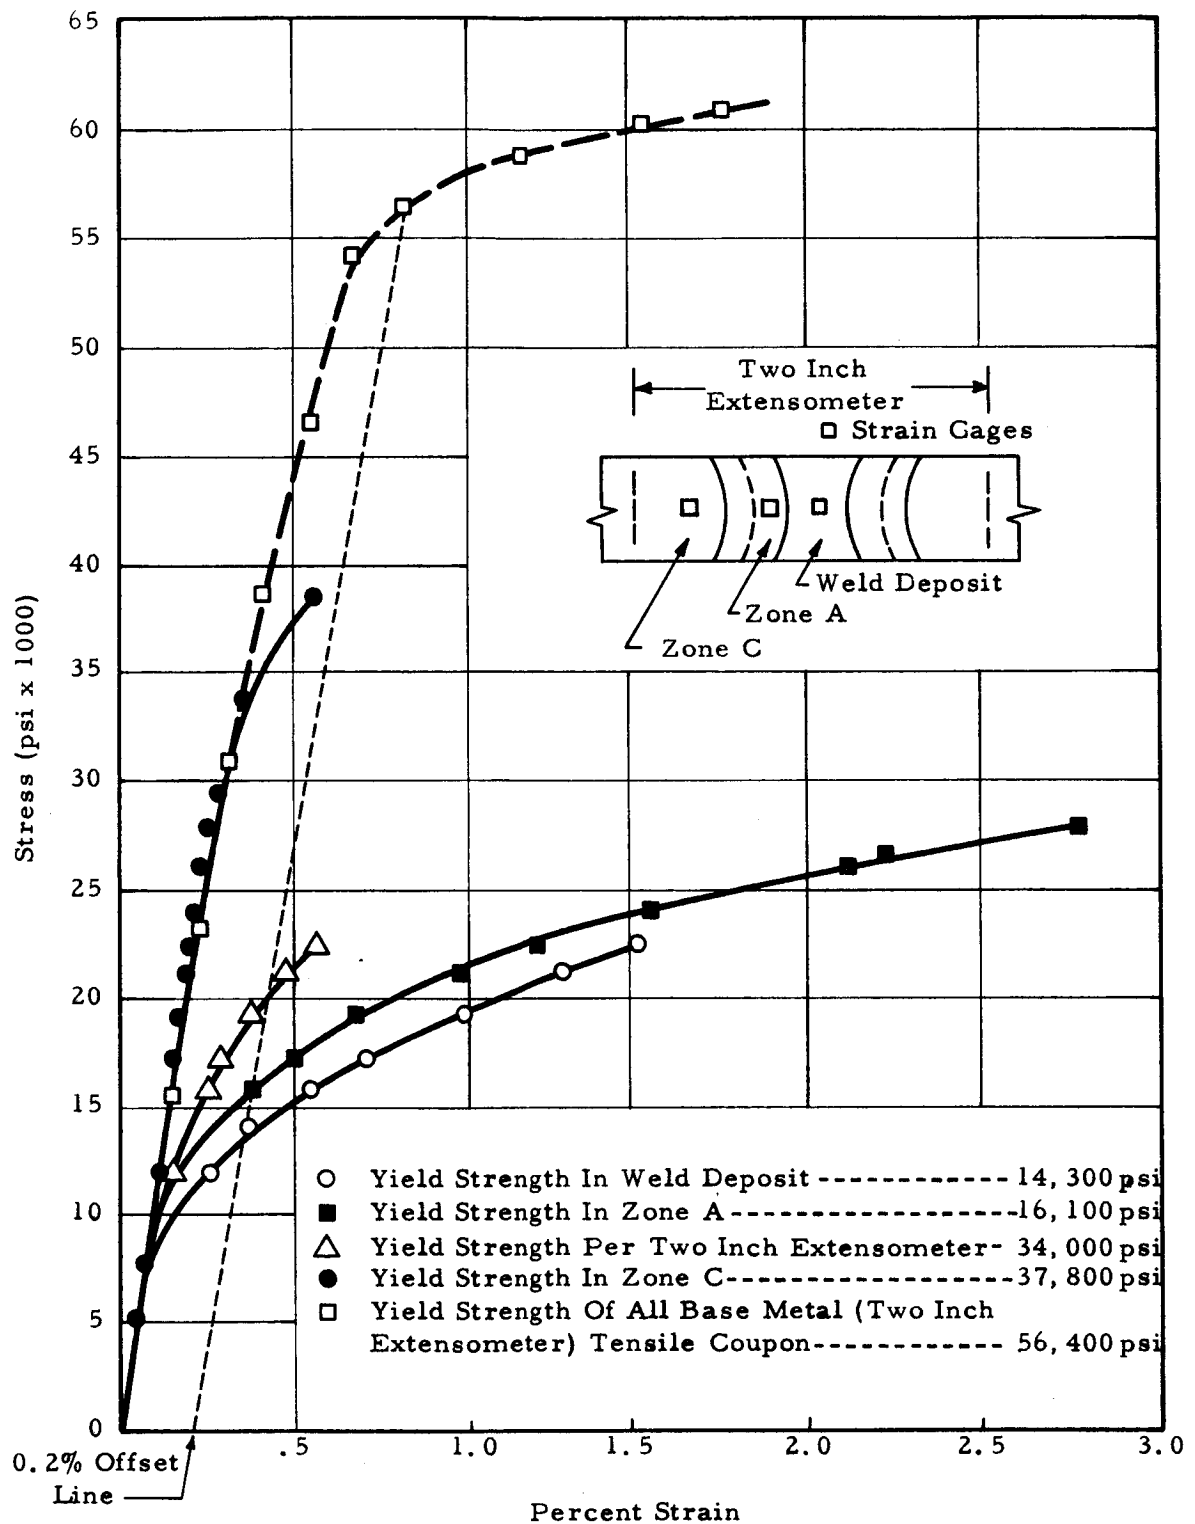
FIGURE 50. STRESS-STRAIN CURVES OF WELD DEPOSIT, ZONE A, ZONE C, AND PER TWO INCH EXTENSOMETER OF TENSILE COUPON WITH WELD CROWNS GROUND FLUSH WITH BASE METAL. Note all base metal (two inch extensometer) curve from different tensile coupon.

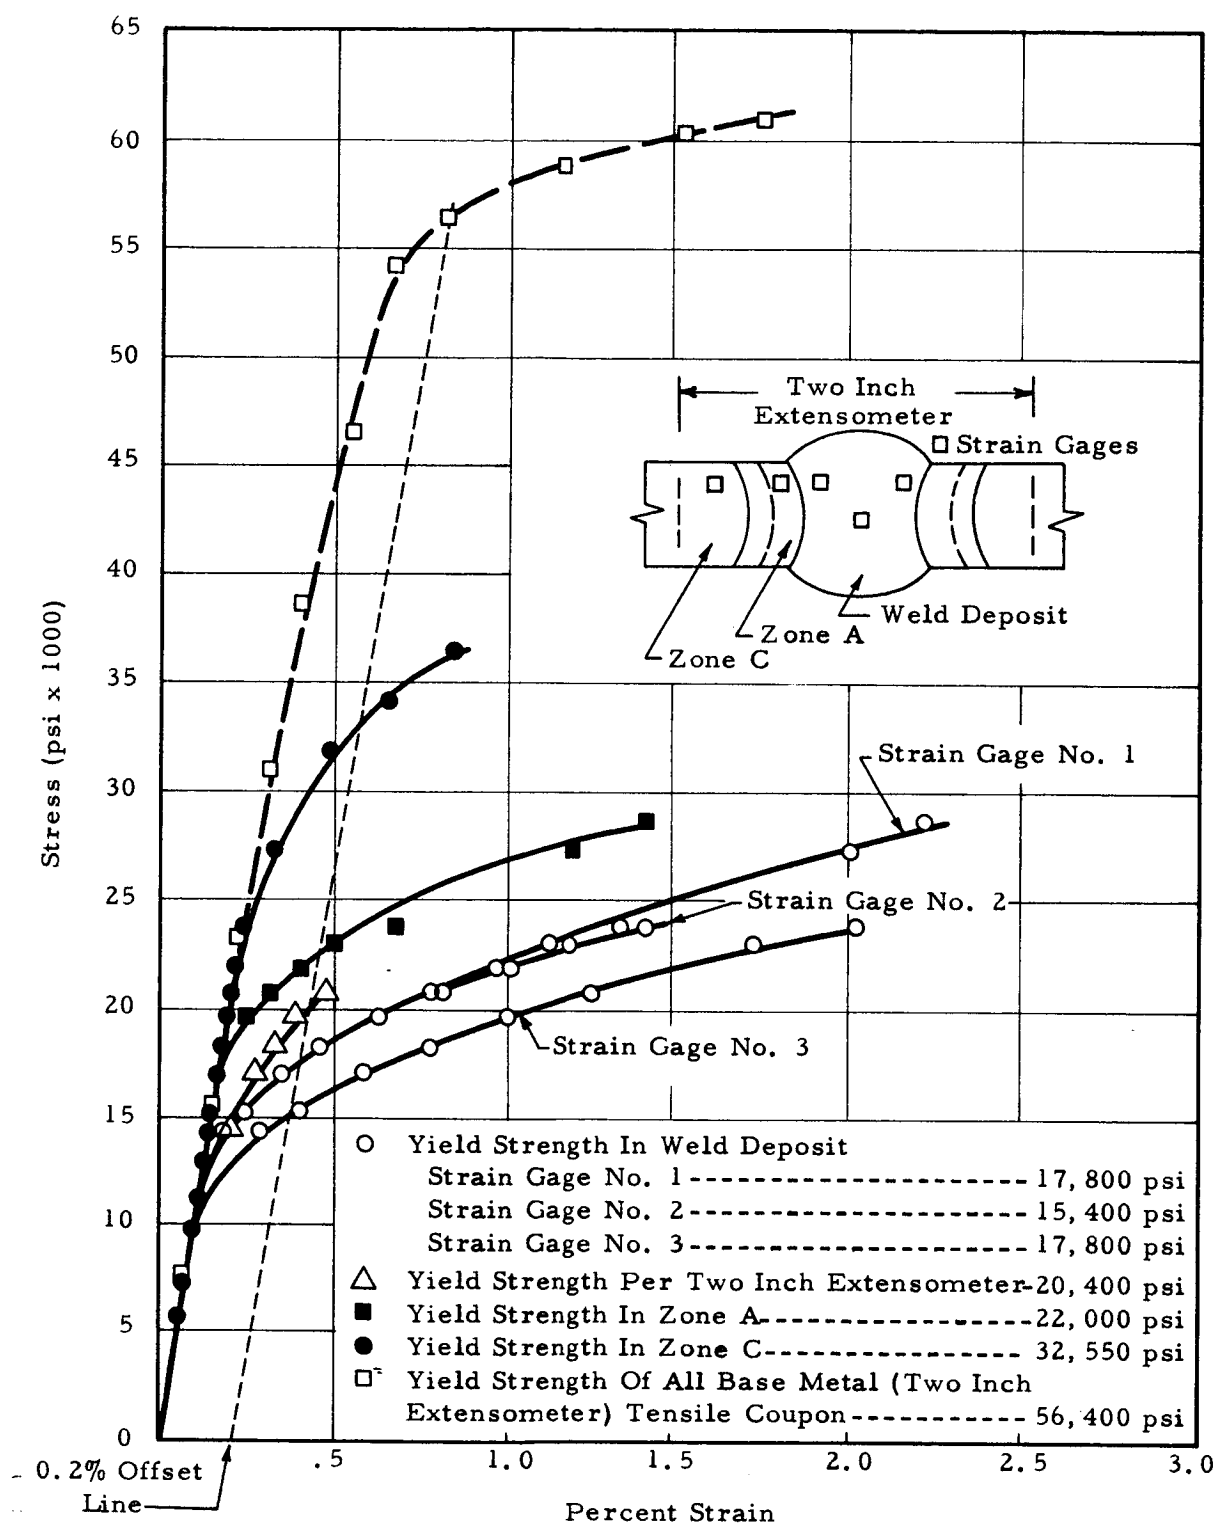
FIGURE 51. STRESS-STRAIN CURVES OF WELD DEPOSIT, ZONE A, ZONE C, AND PER TWO INCH EXTENSOMETER OF LARGE WIDTH-TO-DEPTH WELD RATIO TENSILE COUPON.

Note all base metal (two inch extensometer) curve from different tensile coupon.

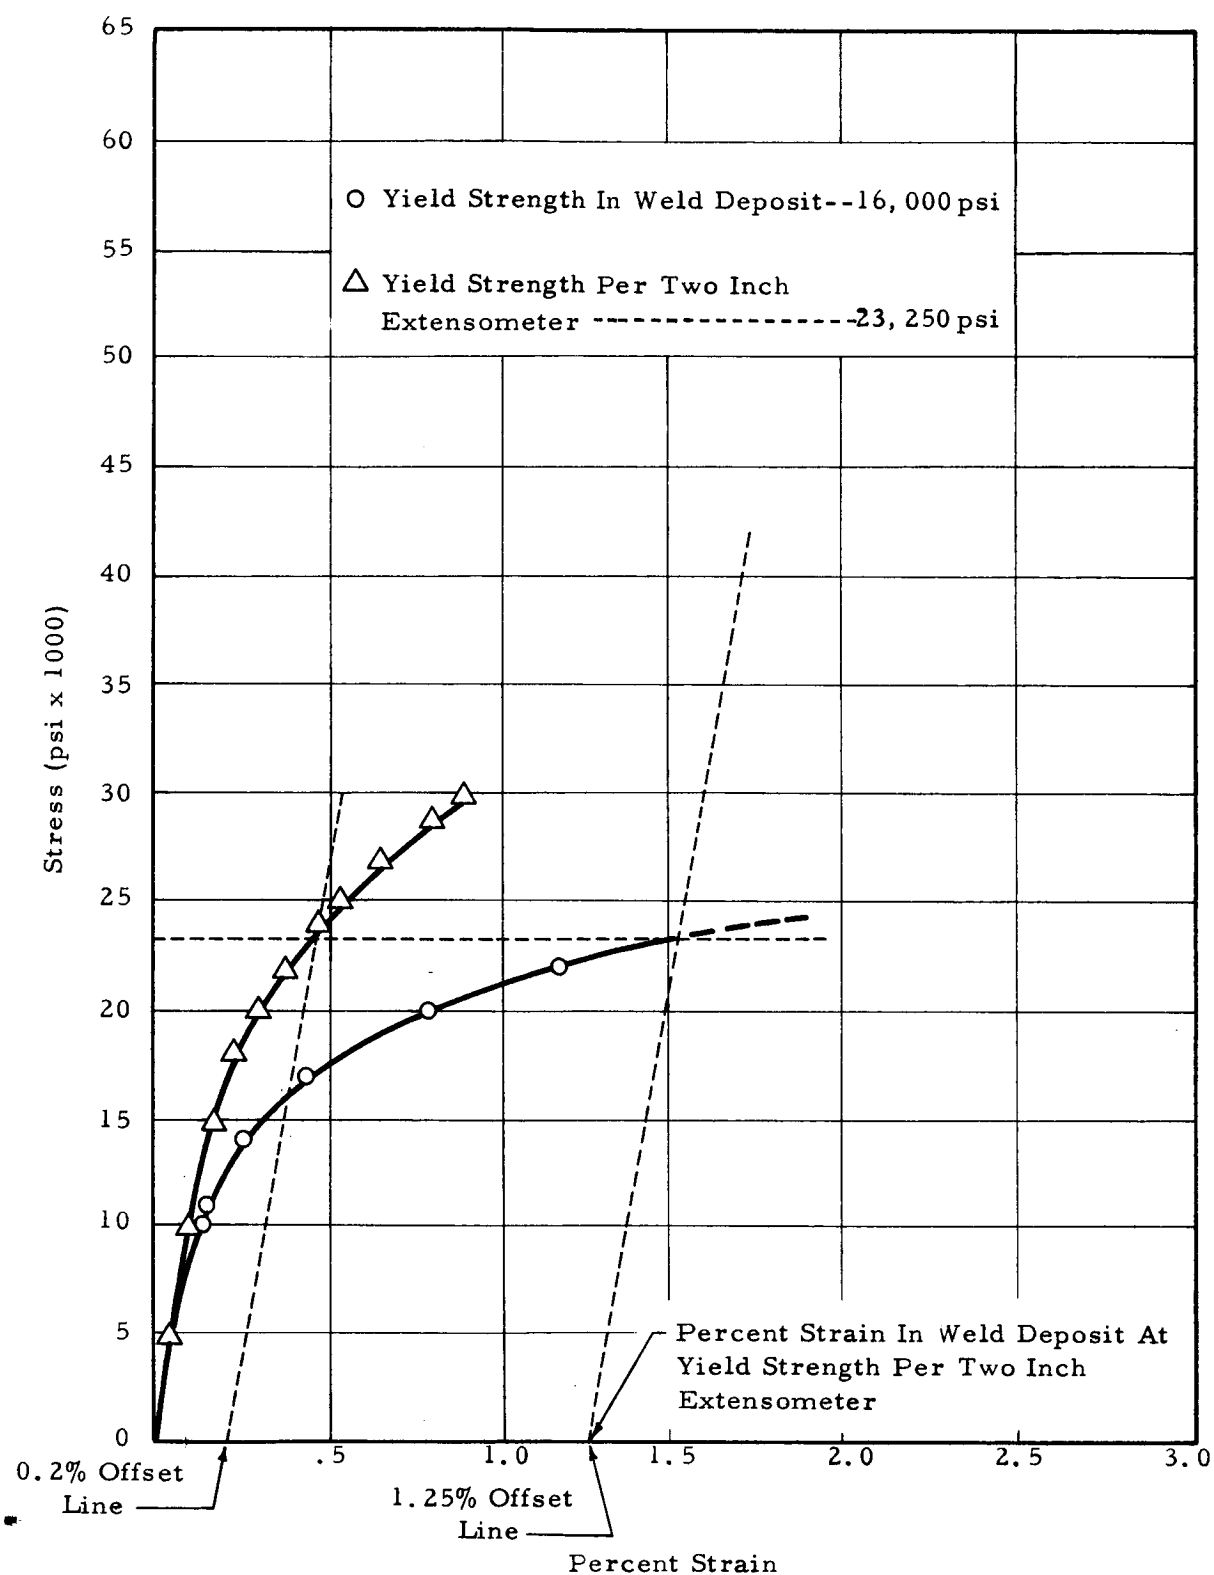
FIGURE 52. PERCENT STRAIN IN WELD DEPOSIT AT YIELD STRENGTH AS RECORDED BY THE TWO INCH EXTENSOMETER. These curves were extracted from Figure 49.

Figure 52 was prepared from data plotted on Figure 49. The latter illustrates that when a standard ASTM two-inch gage length is employed to test weldments the yield strength of the weld deposit is likely to be exceeded long before the specified overall 0.2 percent offset is reached. It is also evident that the use of the "overall" yield strength for design purposes would be extremely hazardous. A more realistic testing method is desirable. The use of short gage lengths in a weld deposit and other limiting zones would be good in theory but rather impracticable in practice. It is felt

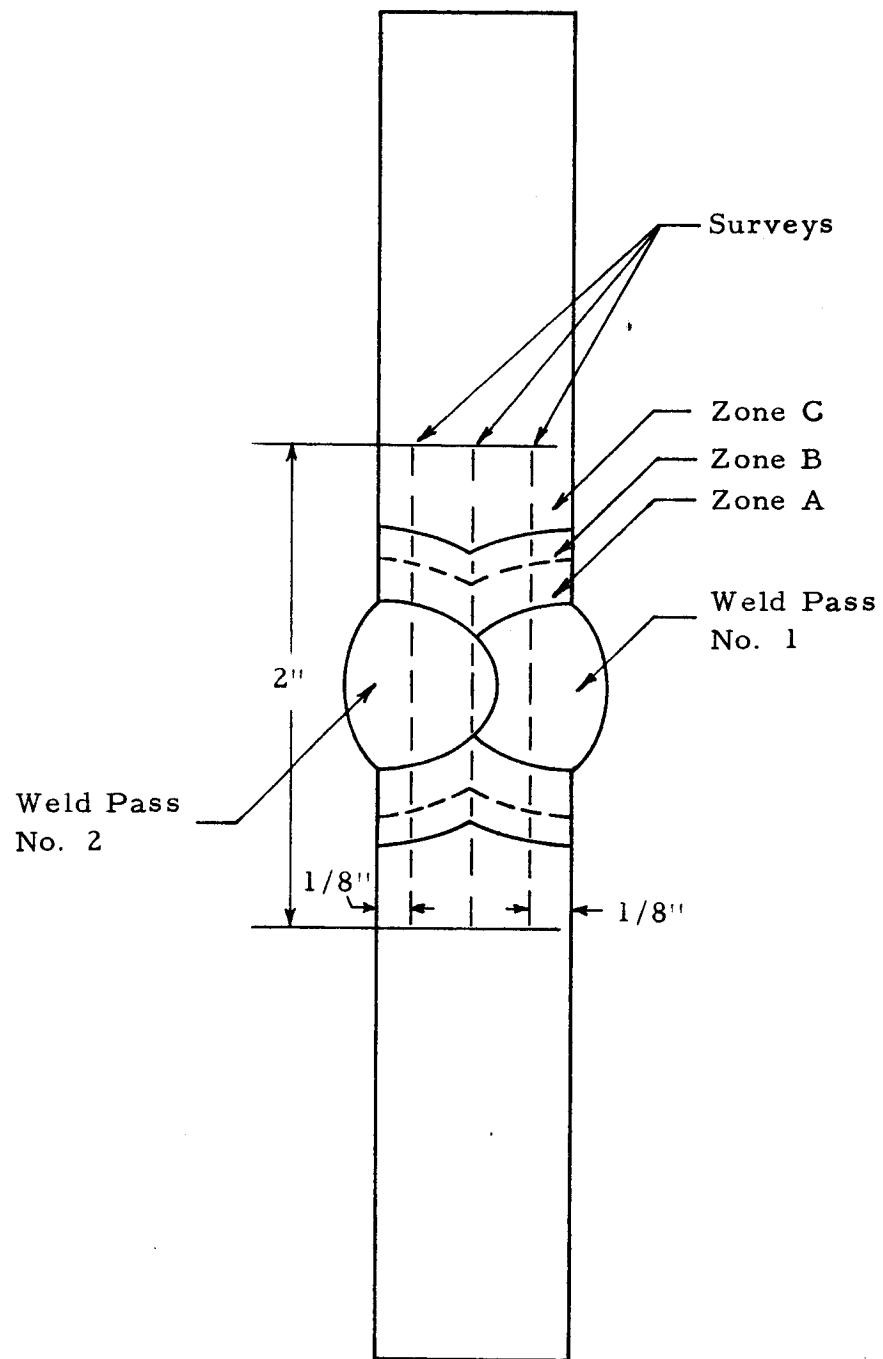
FIGURE 53. LOCATION OF THREE SURVEYS ACROSS TENSILE COUPON TO MEASURE PLASTIC DEFORMATION

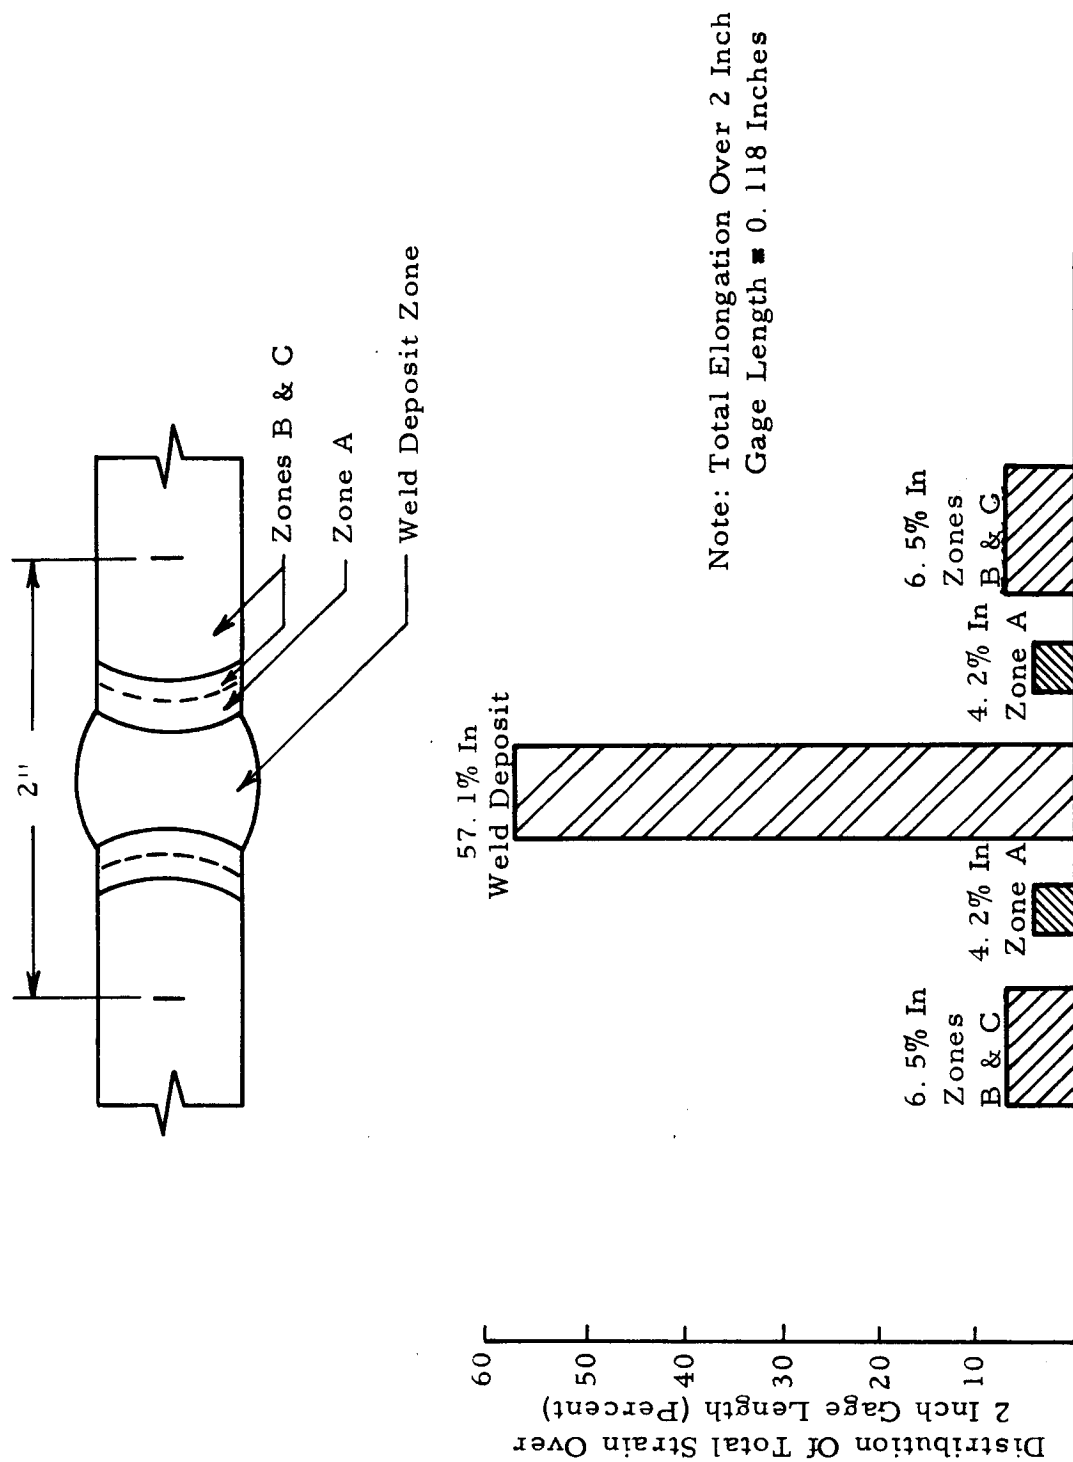
FIGURE 54. PERCENT STRAIN DISTRIBUTION ACROSS WELD JOINT

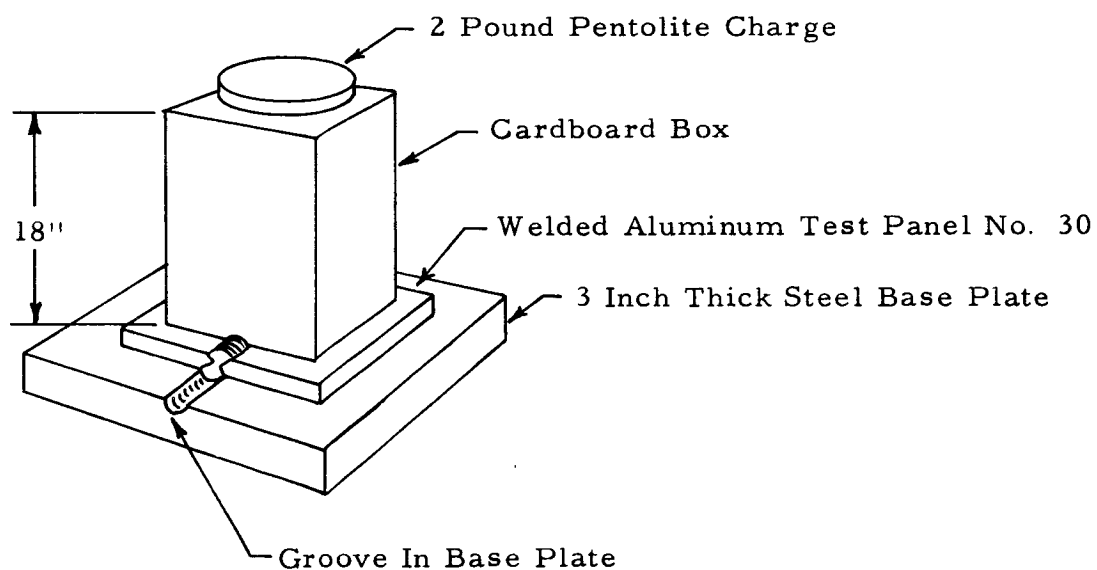
FIGURE 56. EXPLOSIVE IMPACT LOADING OF BUTT-WELDED
3/4 INCH THICK 2219 T87 TEST PANELS

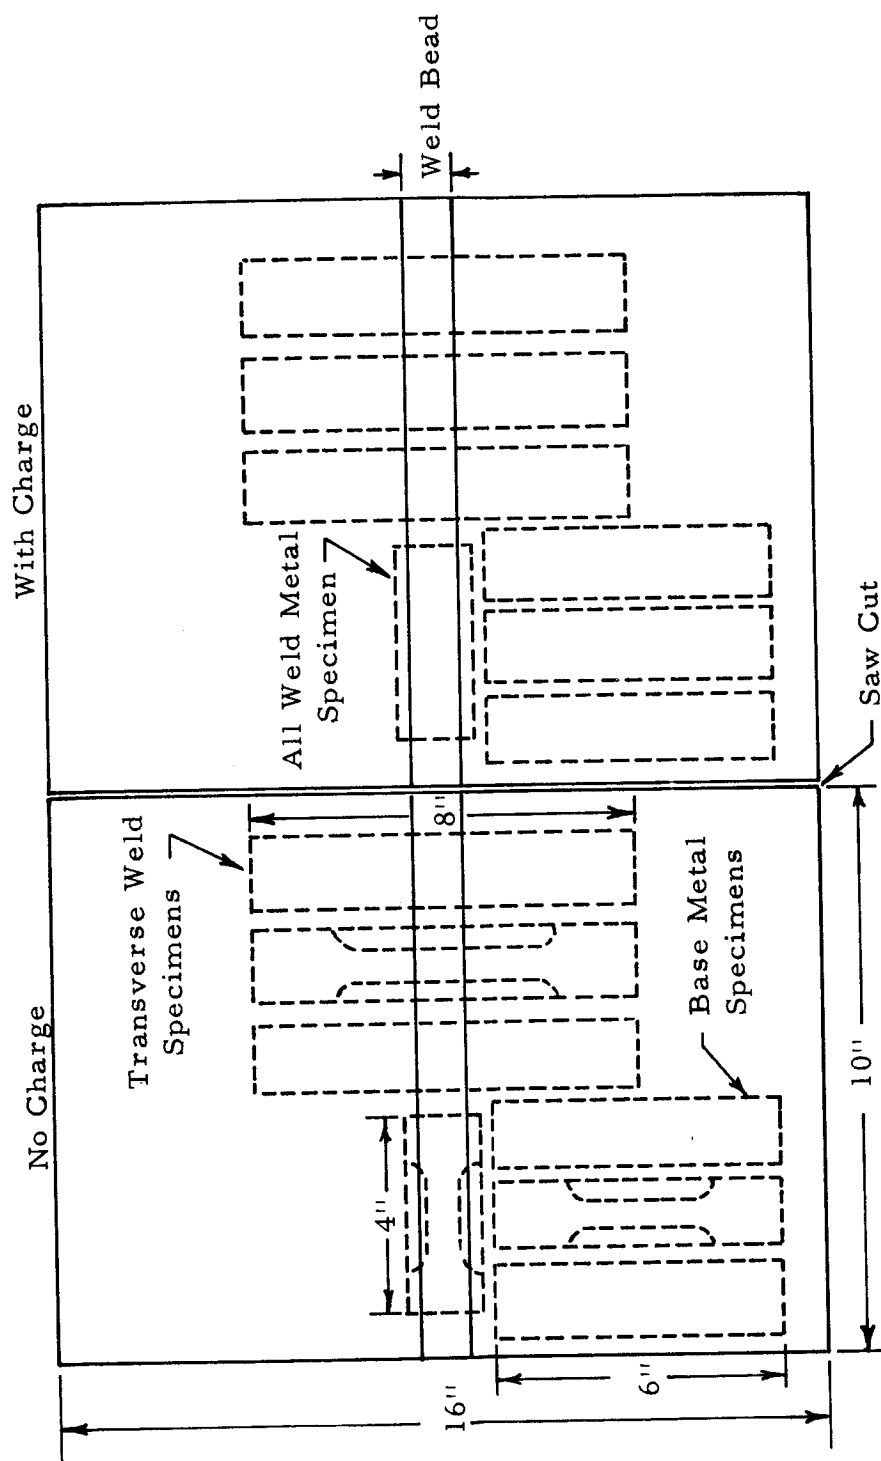
FIGURE 59. SEQUENCE USED IN REMOVING ALL WELD METAL, TRANSVERSE WELD AND BASE METAL TENSILE SPECIMENS FROM 3/4 INCH THICK 2219-T87 BUTT WELDED PANELS

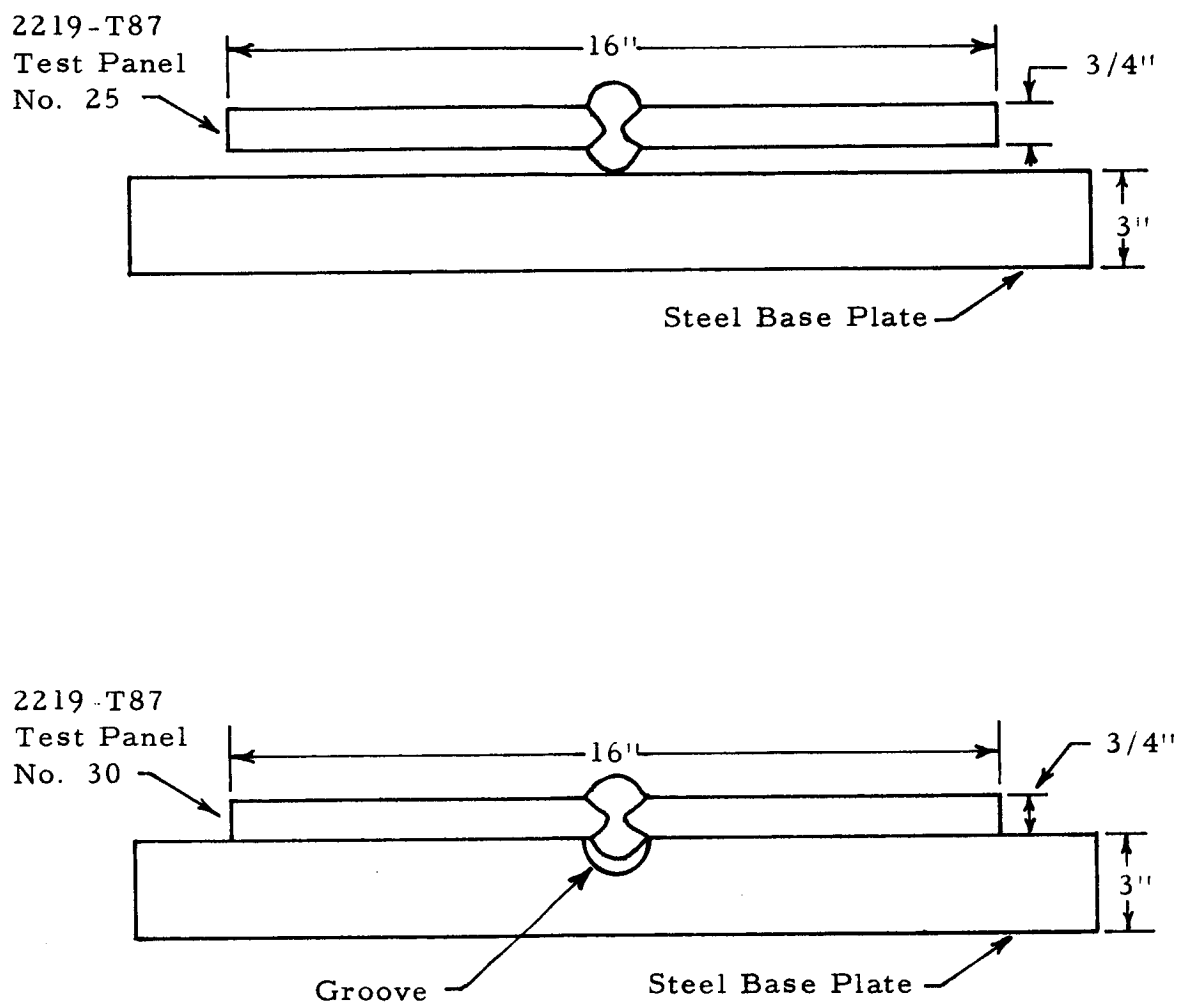
FIGURE 60. RELATIVE POSITIONS OF 3/4 INCH THICK 2219-T87 TEST PANELS NUMBERS 25 AND 30 ON THE STEEL BASE PLATE

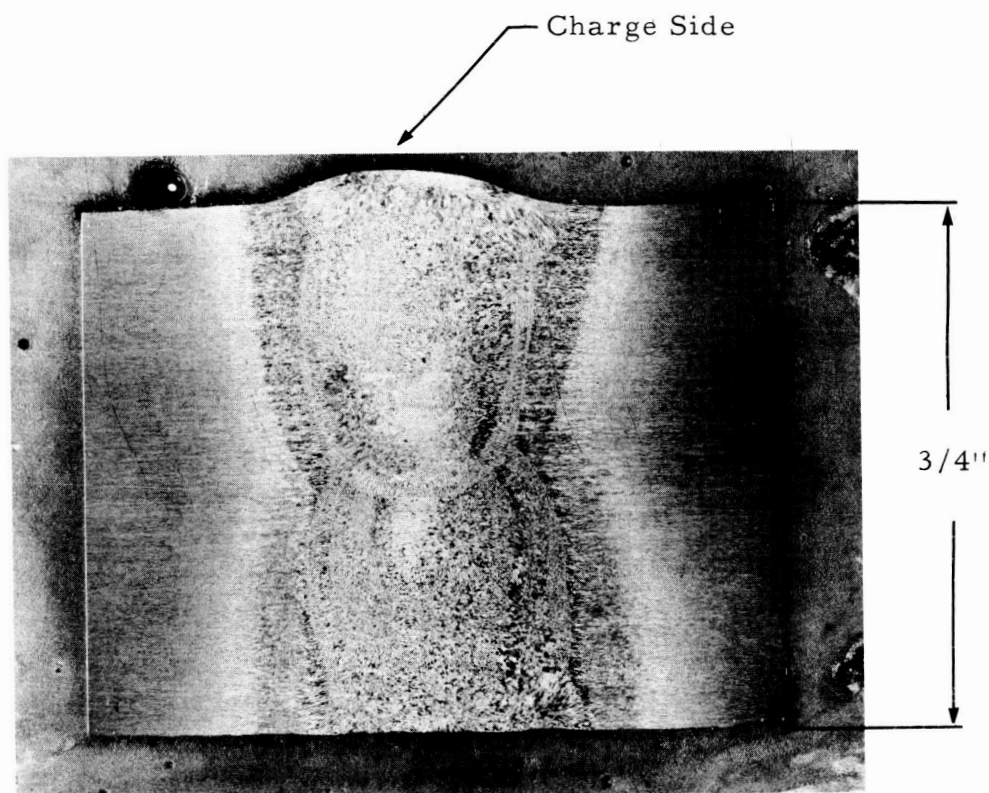
FIGURE 61. CROSS-SECTION OF THE WELD FROM TEST PANEL NO. 25. Panel was fabricated from $3/4$ inch thick 2219-T87 aluminum plate. A four pound charge of pentolite was fired above the panel. Note that the weld crown at the bottom surface was flattened out when the panel was forced against the steel base plate. This gross plastic deformation resulted in the refinement of the coarse columnar grain structure found in the crown area of the joint.

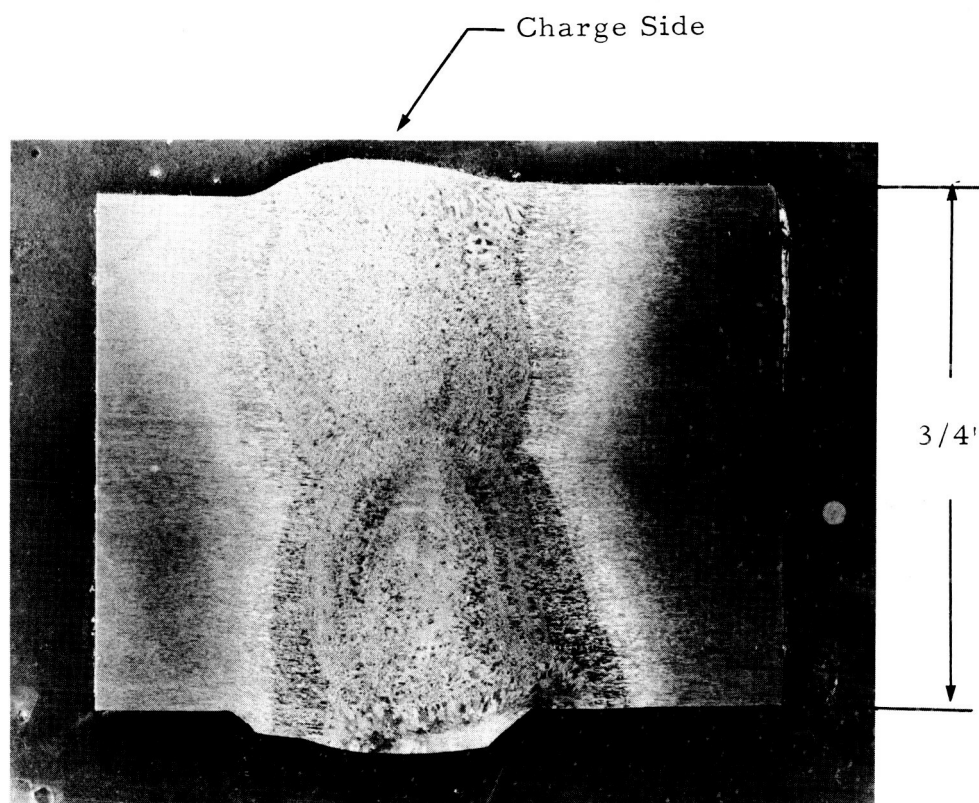
FIGURE 62. CROSS-SECTION OF THE WELD FROM TEST PANEL NO. 30. Panel was fabricated from 3/4 inch thick 2219-T87 aluminum plate. A two pound charge of pentolite was fired above the panel. The weld crown at the bottom surface of the panel was forced into the base plate groove and has assumed the contour of the sides and bottom of the groove.

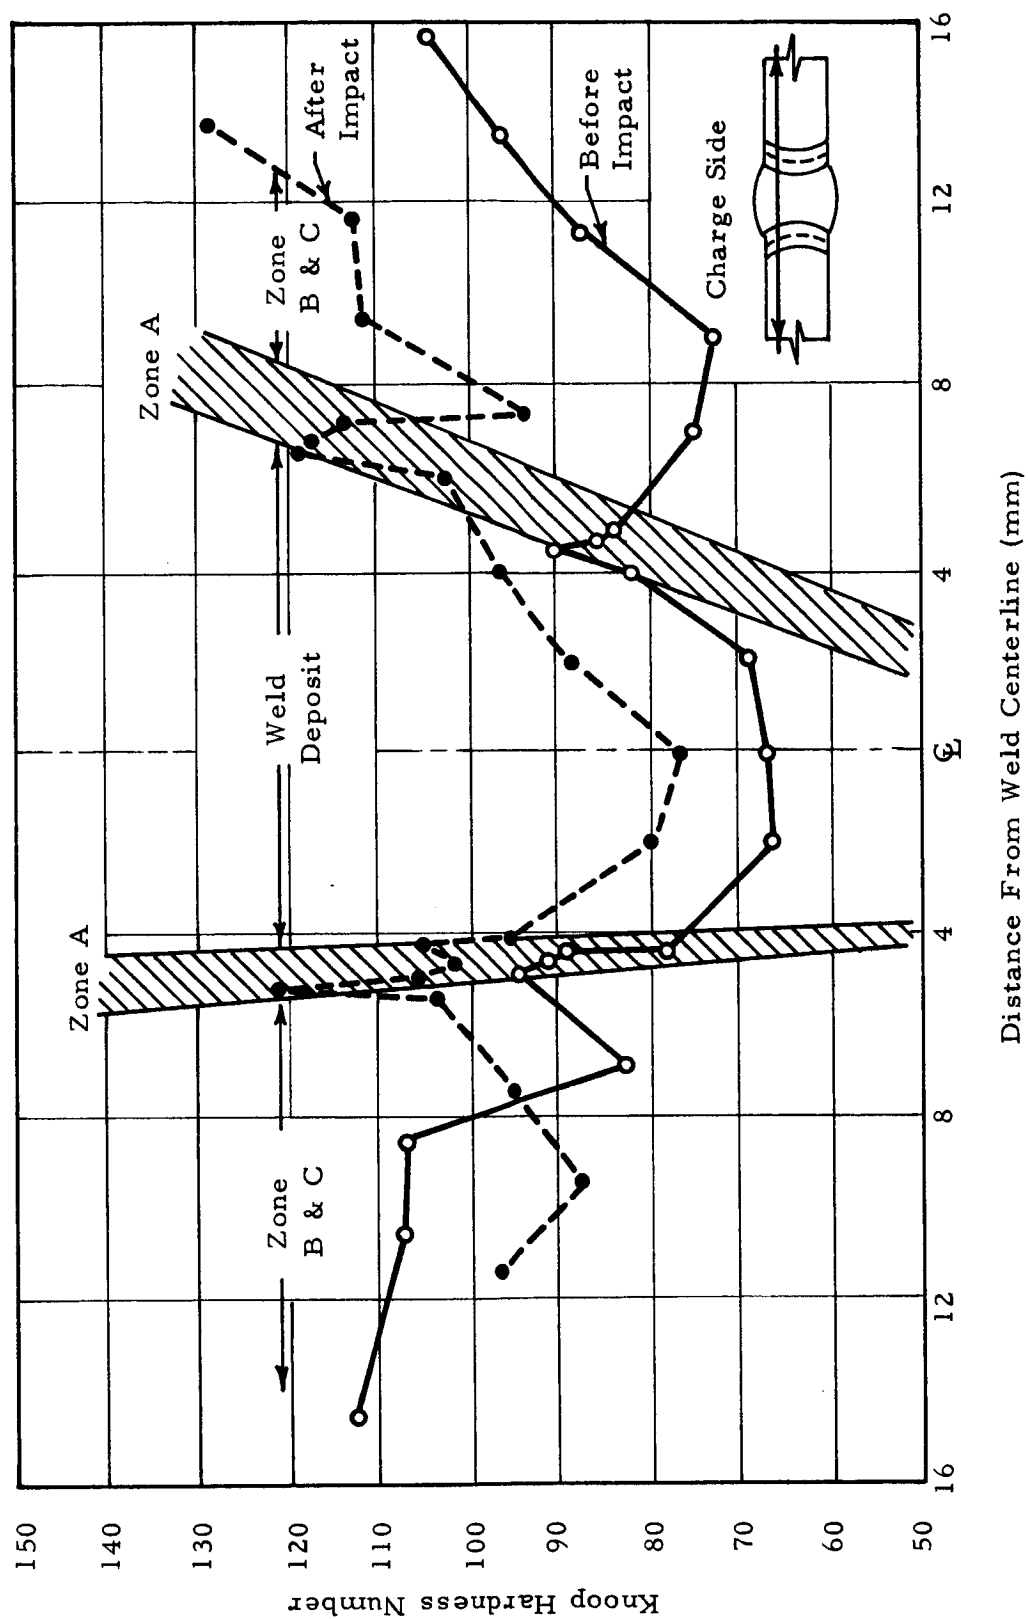
FIGURE 63. EFFECT OF EXPLOSIVE IMPACT LOADING ON WELD ZONE HARDNESS OF PANEL NO. 30. Panel was subjected to a two pound charge of pentolite.

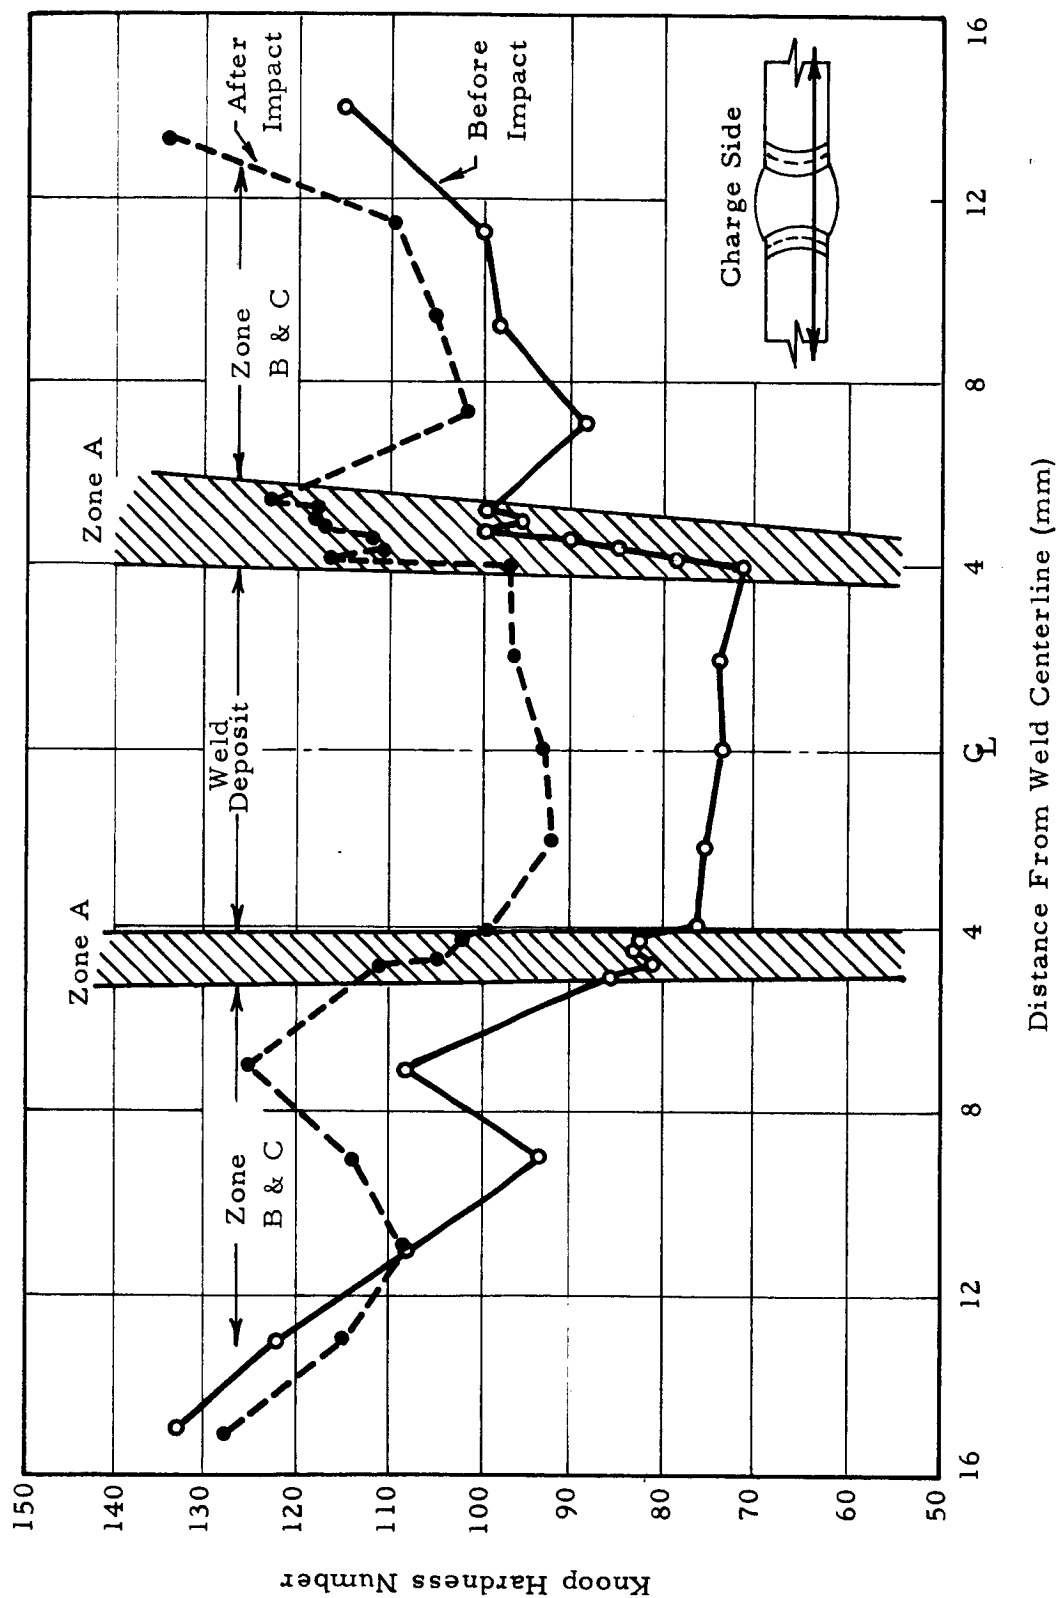
FIGURE 64. EFFECT OF EXPLOSIVE IMPACT LOADING ON WELD ZONE HARDNESS OF PANEL NO. 30. Panel was subjected to a two pound charge of pentolite. Insert shows location of traverses.

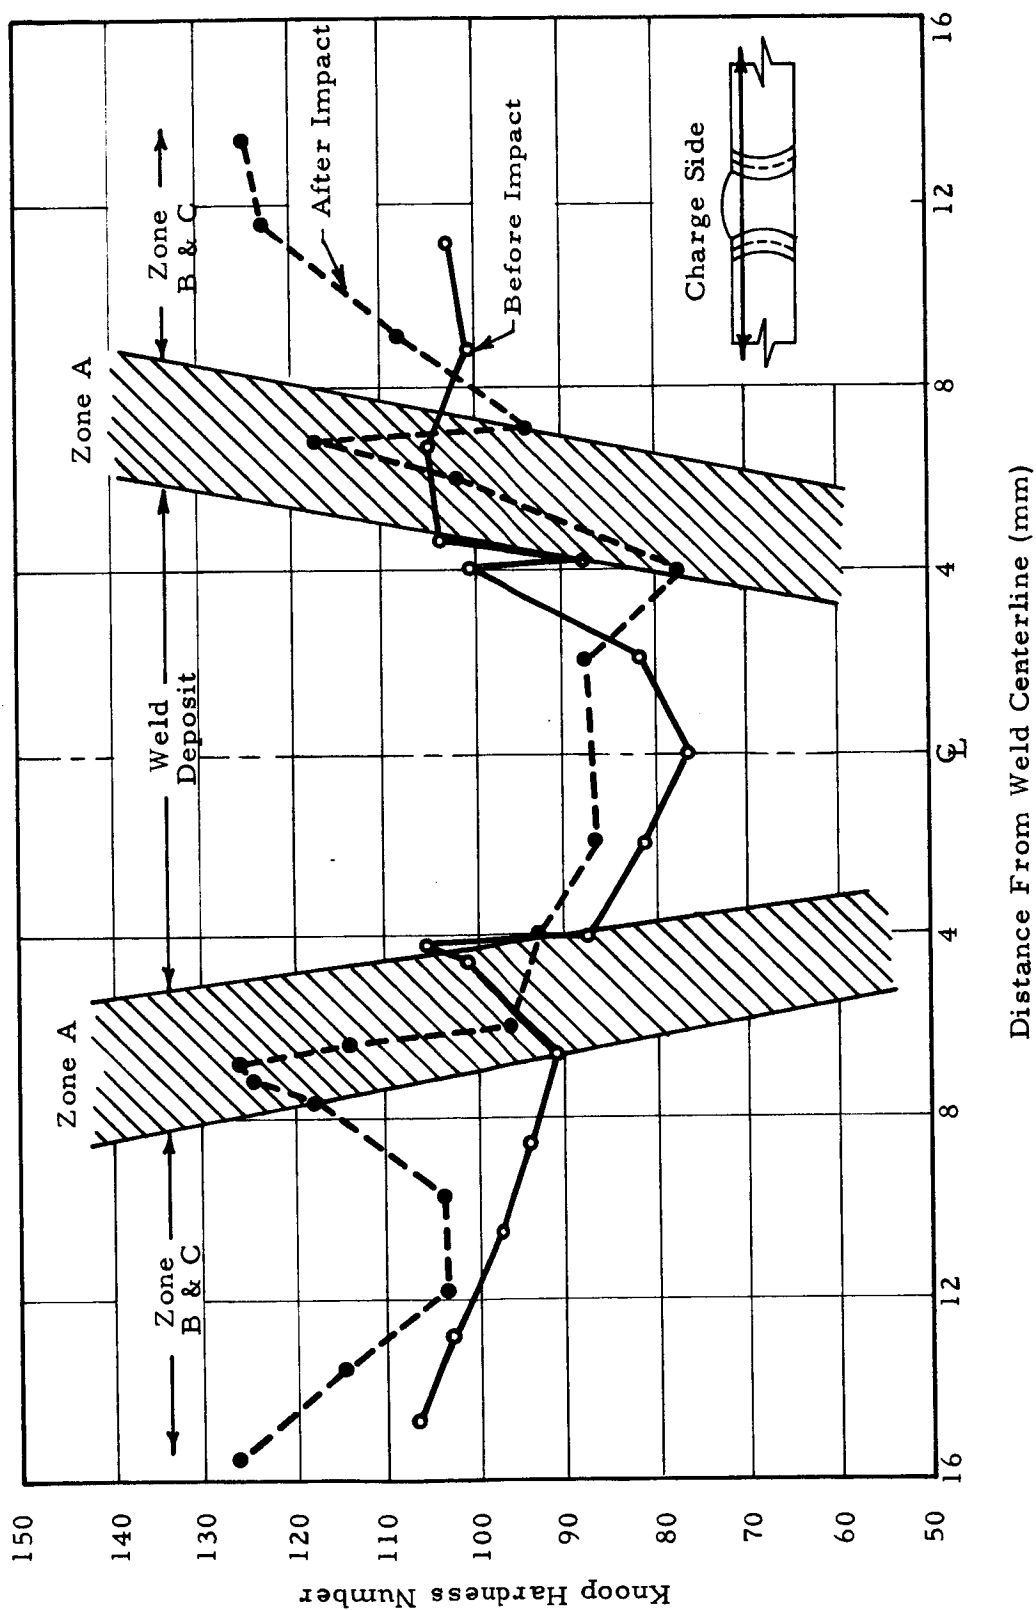
FIGURE 65. EFFECT OF EXPLOSIVE IMPACT LOADING ON WELD ZONE HARDNESS OF PANEL NO. 25. Panel was subjected to a four pound charge of pentolite. Insert shows location of traverses.

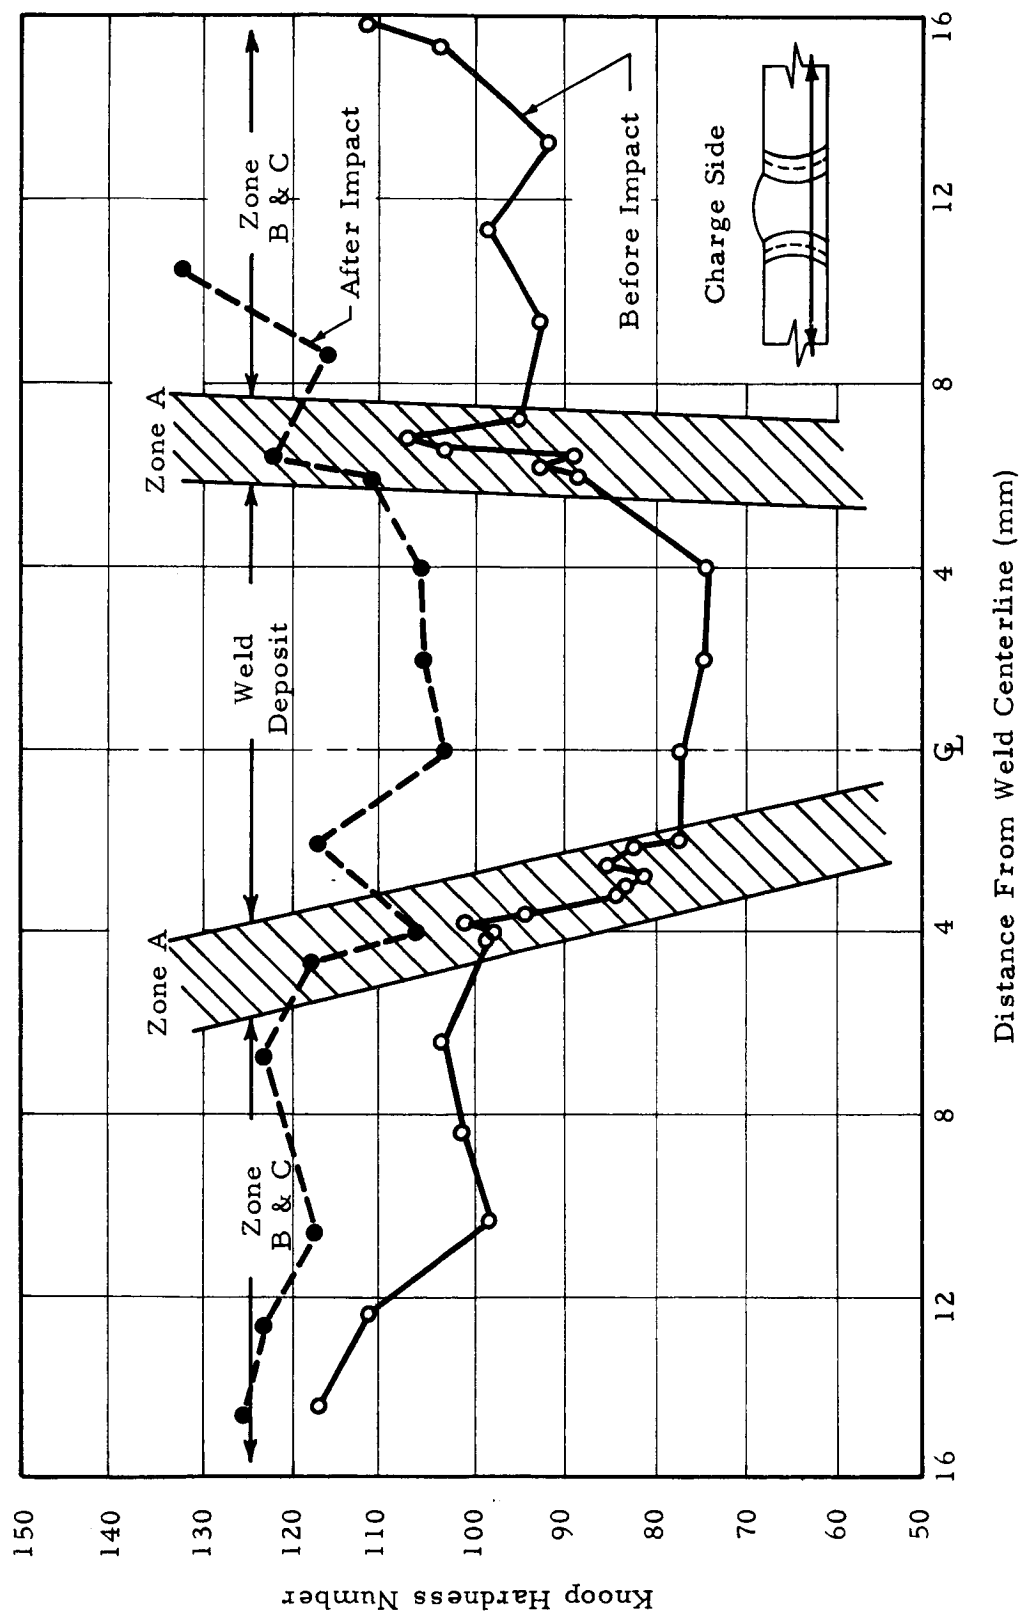
FIGURE 66. EFFECT OF EXPLOSIVE IMPACT LOADING ON WELD ZONE HARDNESS OF PANEL NO. 25. Panel was subjected to a four pound charge of pentolite.

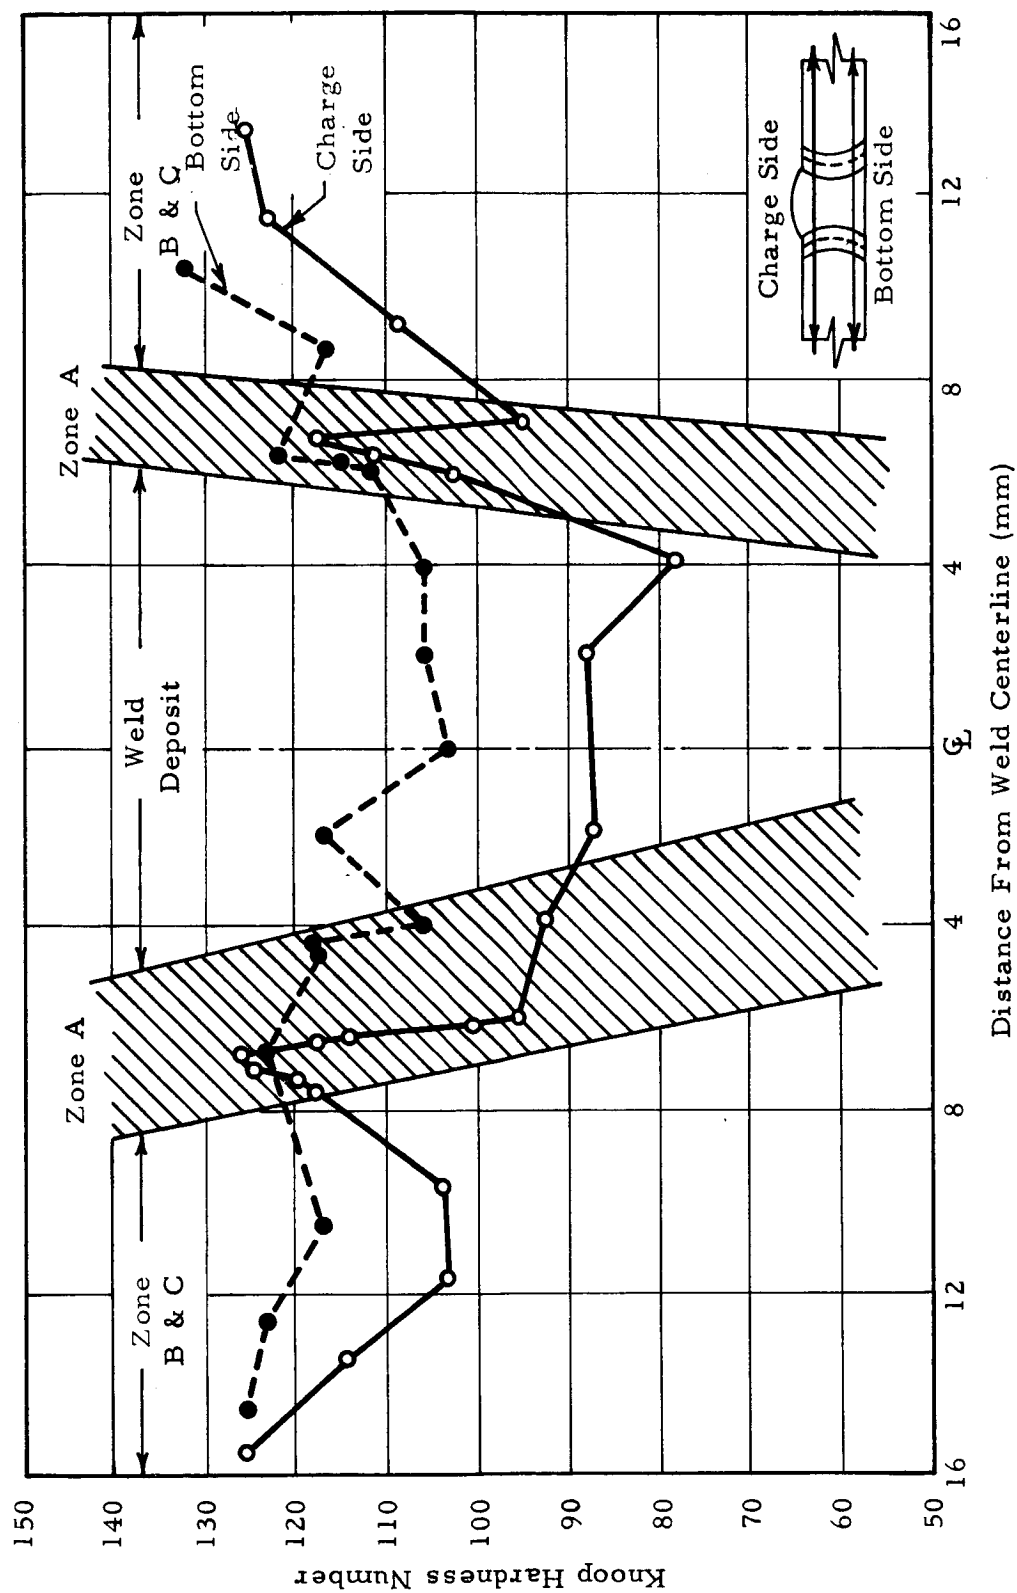
FIGURE 67. INCREASE IN WELD ZONE HARDNESS DUE TO FLATTENING OUT OF WELD CROWN ON BOTTOM SIDE OF PANEL NO. 25.

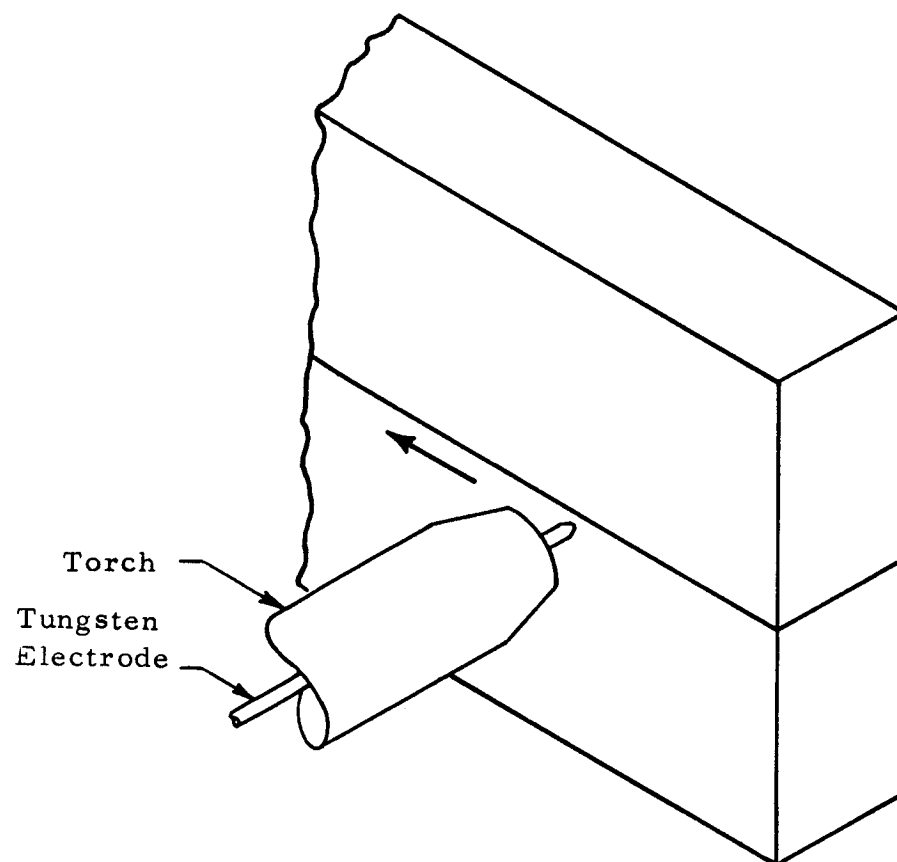
FIGURE 68. HORIZONTAL TIG WELDING
